Our reference  
V-USA-1-0-10

**Subject: VELUX® SKYLIGHT REPLACEMENT CLADDING PARTS**

## Skylight Deck Mount Models - Pictorial

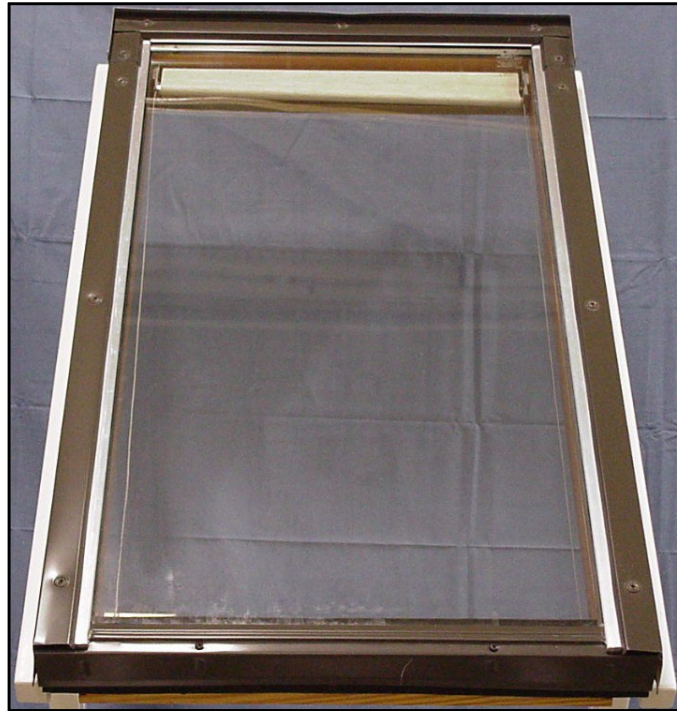
**FS M82 / FS M85 / FS M87****Mfg 12/1982 – 03/1995**

No replacement cladding parts.  
Skylight replacement only.  
Distinguished by exterior screws  
through the top of the cladding  
covers

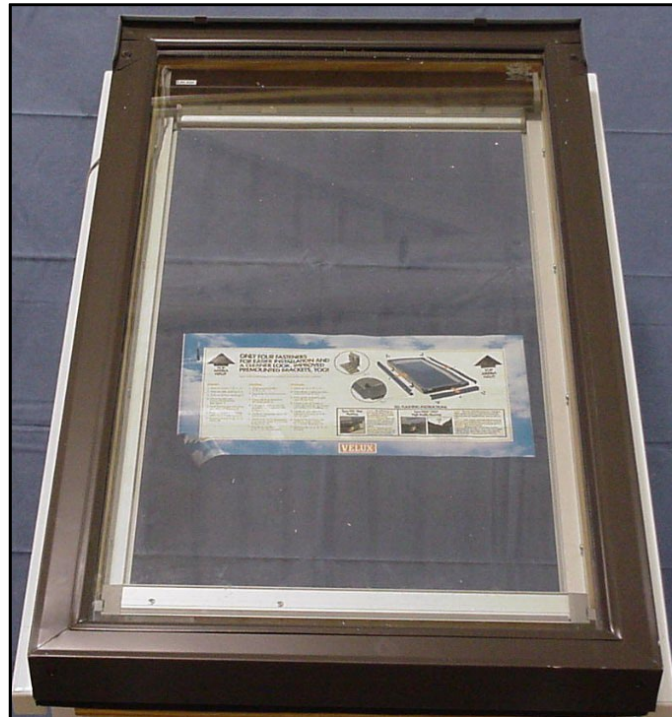
**FS M95****Mfg 04/1995 – 05/2004**

No replacement cladding parts.  
Skylight replacement only.

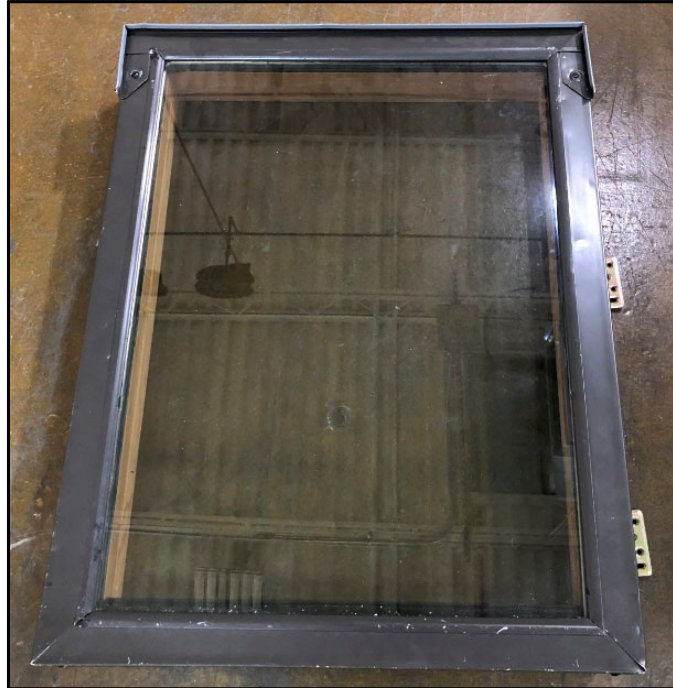
**FS H04****Mfg 05/2004 – 12/2009**

No replacement cladding parts.  
Skylight replacement only.

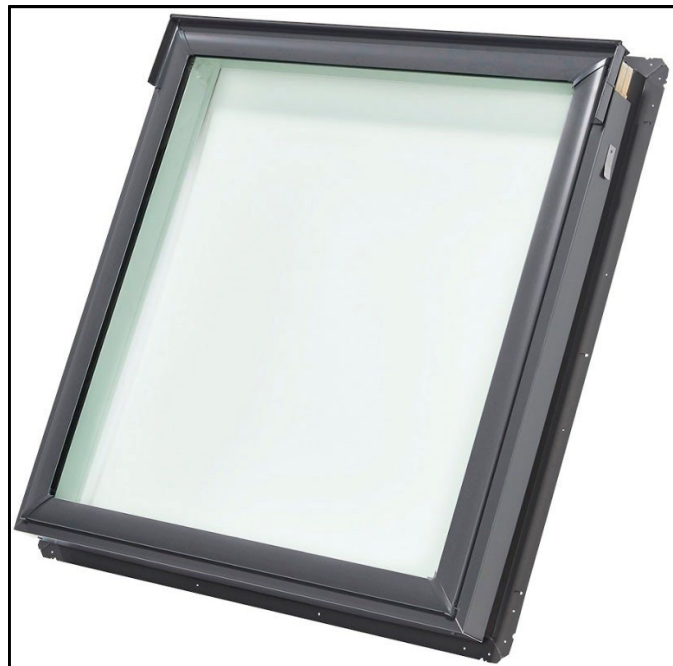
**FS A21****Mfg 01/2010 – Present**

Replacement cladding parts only  
for frame cladding covers,  
otherwise complete skylight  
replacement.

Distinguishing features are  
rounded glazing profile cladding  
and light grey color.

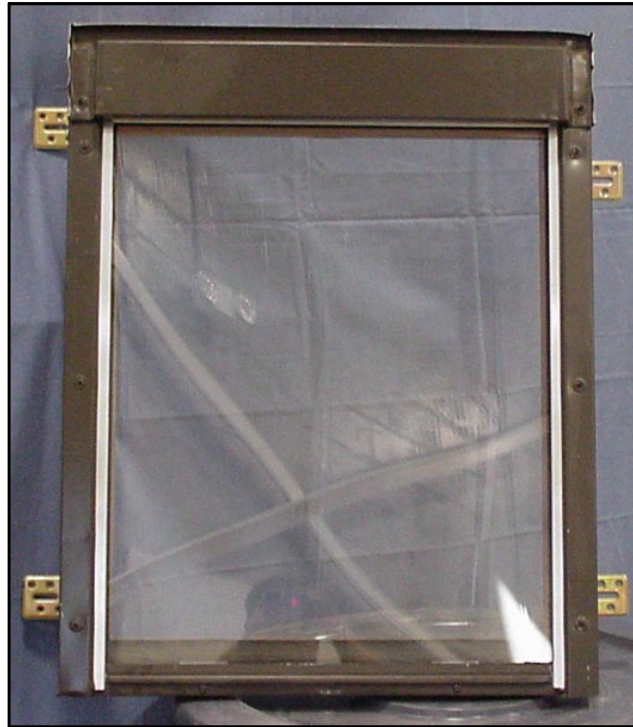
**FSF M87****Mfg 03/1987 – 02/1995**

No replacement cladding parts.  
Skylight replacement only with  
fixed or venting skylight.  
Distinguished by exterior screws  
through the top of the cladding  
covers

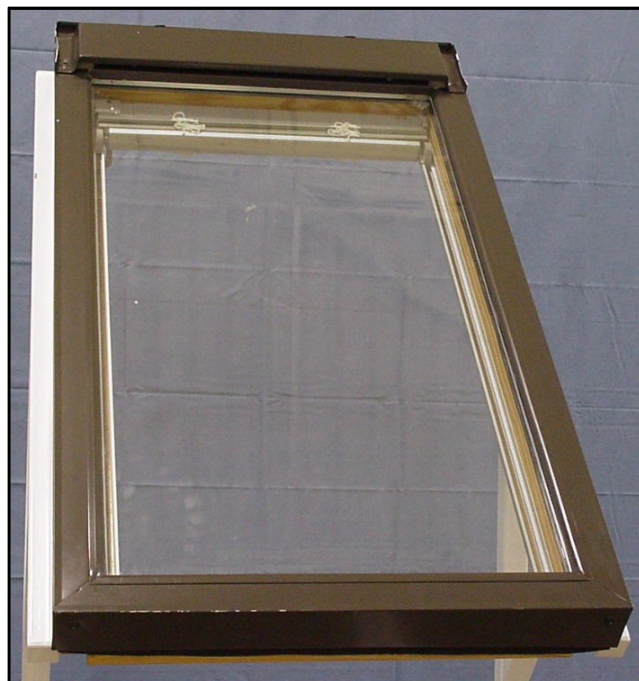
**FSF M95****Mfg 03/1995 – 07/2007**

No replacement cladding parts.  
Skylight replacement only with  
fixed or venting skylight.

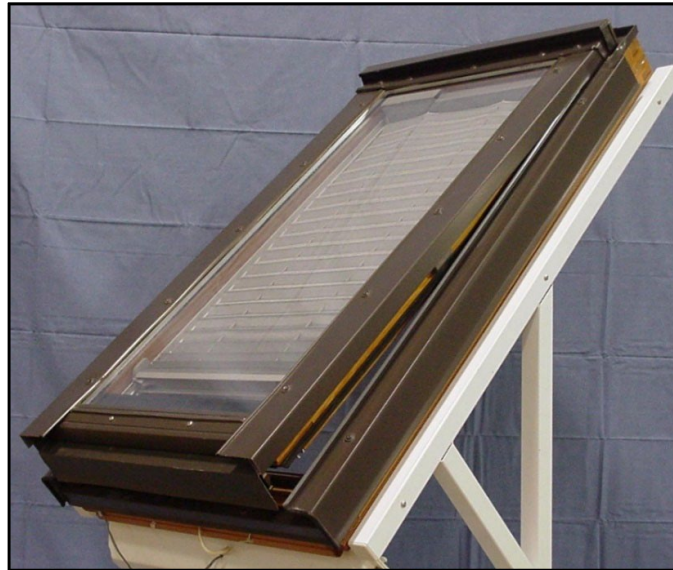
**VS M84 / VS M87 / VSC****Mfg 02/1983 – 01/1996**

No replacement cladding parts.  
Skylight replacement only.  
Distinguished by exterior screws  
through the top of the cladding  
covers

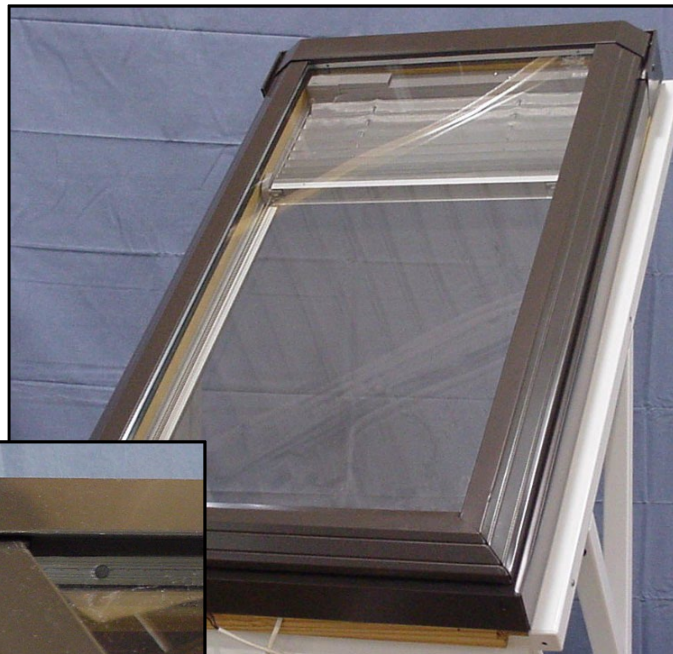
**VS M96 / VS M96B****Mfg 02/1996 – 02/1998**

No replacement cladding parts.  
Skylight replacement only.  
Distinguished by no exterior  
screws in the side and bottom  
claddings and shape of top cladding  
cover.

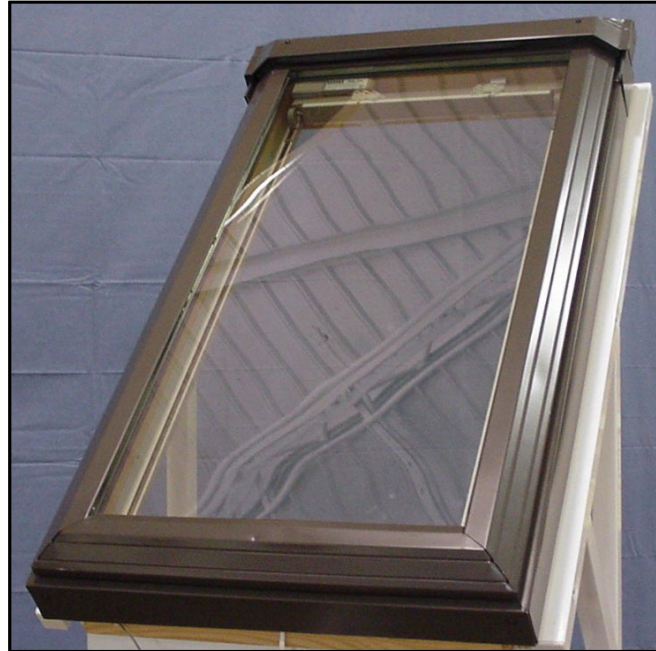
**VS / VSE H04**  
**Mfg 05/2004 – 12/2009**

No replacement cladding parts.  
Skylight replacement only.

Distinguished by shape of top  
cladding cover.

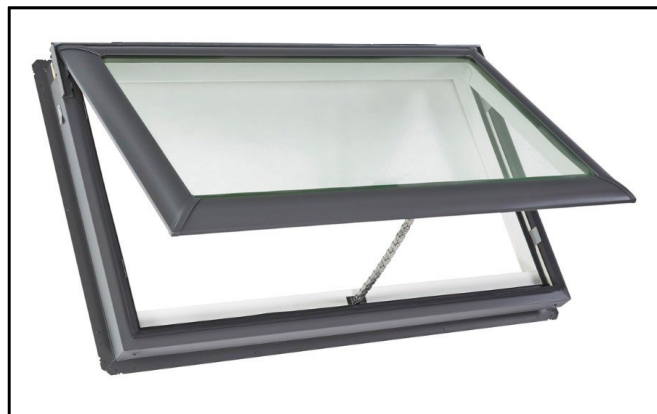
**VS / VSE / VSS A21**  
**Mfg 01/2010 – Present**

Frame cladding parts available.  
Sash complete required if sash  
cladding damaged.

Distinguished by rounded sash  
cladding and light grey color.
